## **Wasa Lake Foreshore Inventory and Mapping**

**Prepared for:  
Wasa Lake Land Improvement District**

**Final Report  
February 2009**

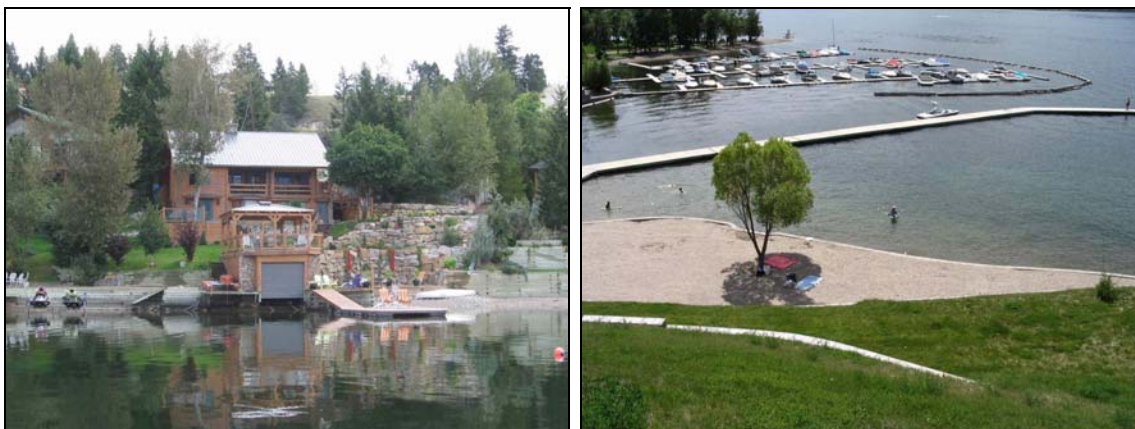
**Figure 3. Examples of foreshore modifications including boathouse, dock, retaining wall (left); and marina, dock and retaining wall (right, [photo of Windermere Lake provided by Wildsight]).**

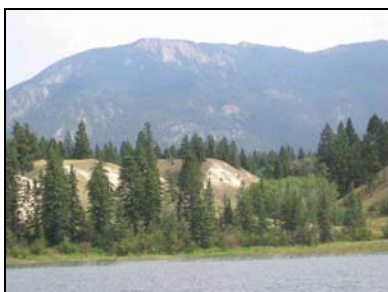
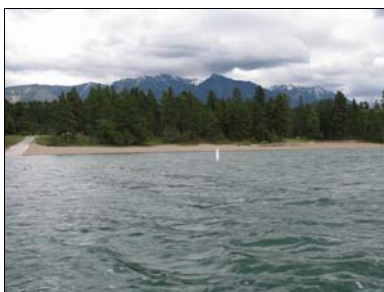
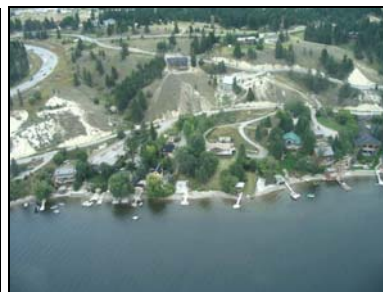
**Figure 4. Examples of low, medium and high levels of impact along foreshores.**

Low Level of Impact

Medium Level of Impact

High Level of Impact

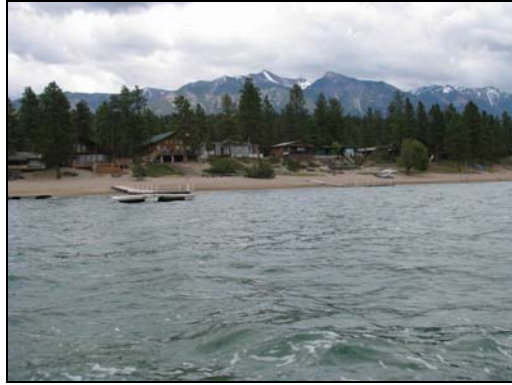
- ♦ The Sand/Cobble Beach Shore Type was not evident during high water levels, but at low water levels appeared prevalent in many segments around the lake (Figure 10). This was considered an important shore type to distinguish, particularly because many, but not all, of the areas where the Sand Beach Shore Type were found, were anticipated to likely have been the result of extensive beach grooming (sand placement) primarily for recreational purposes. The placement of sand appeared in both park and residential segments and will be discussed in the following section.

**Figure 10. Segment 1, showing extensive sandy beach at high water, however, this area was extensively covered with cobble substrate at lower water levels.**

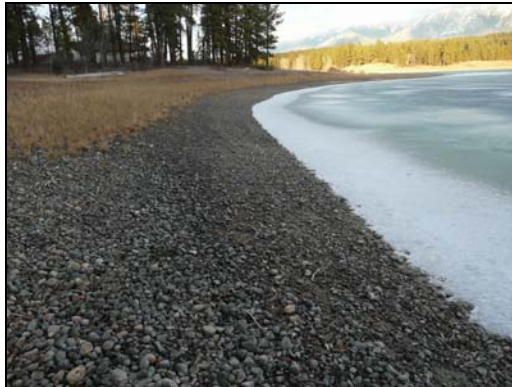
- ◆ Although Segment 6 was classified as a Vegetated Shore Type, substantial sections of cobble were identified along the shoreline at low water levels, and at high water levels (as evidenced through the orthophotos) (Figure 11). In this location, there were two overlapping shore types and it was decided that the intact vegetation along the shoreline was the significant feature for classification.

**Figure 11. Cobble shoreline following the base of the Vegetated shore type of Segment 6.**

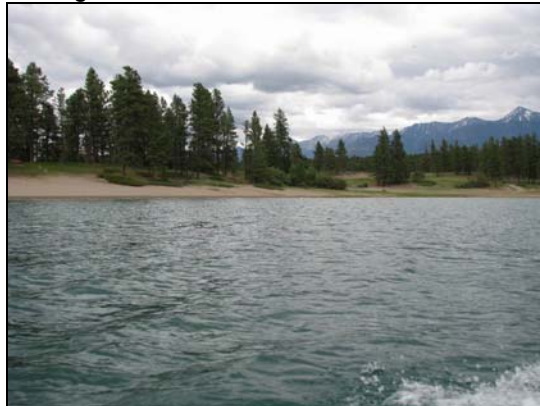
- ◆ Grassland areas and open forests with grassland understory were observed in several segments around the lake, including Segments 2, 8, 9 and 10. These included open ponderosa pine forest containing a grassy understory (e.g., Segments 8 and 10) as well as grassy fields without the mature conifers (Segment 2). Segment 9 also had sections of grassland which had not yet been impacted by development. These were classified in with the Vegetated Shore Types. Appendix C provides the orthophoto delineation completed by Terrasaurus, delineates grassland features around the lake.

**Figure 12. Ponderosa pine open forest in the riparian and upland areas of Segment 8.**

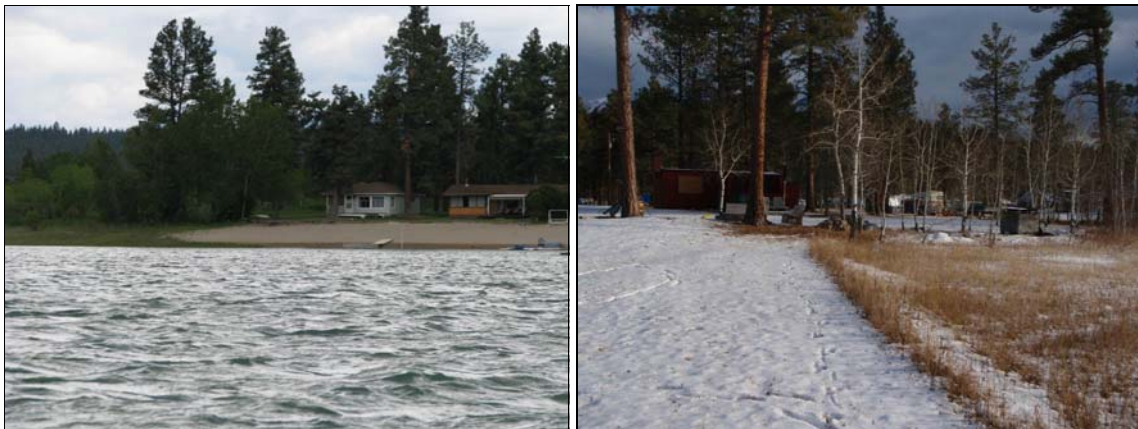
Considering all segments, 36% of the total foreshore length was estimated to have been beach groomed. Substantial beach grooming (>50%) has occurred in the residential Segments 1, 3, 5 and 7, and the park-Segment 10. Figure 14 provides beach grooming examples from sites in Segments 1 and 5. The photos clearly depict the “grooming line”, showing the contrast of the sandy or unvegetated beaches up against the vegetative features of the neighbouring shoreline, which in the case of the left photo is a park in a natural state (Segment 4). Maintaining a natural vegetative cover is preferable, and this has been done in some cases, while allowing for recreational use of the beach (Figure 15). In this photo, the dock has been placed at the low water mark and the vegetation and substrates higher on the shoreline were left intact.

**Figure 14. Examples of beach grooming: vegetation has been removed and sand has been placed along the shoreline of Segment 5 (left), and vegetation has simply been mowed in Segment 1 (right),**

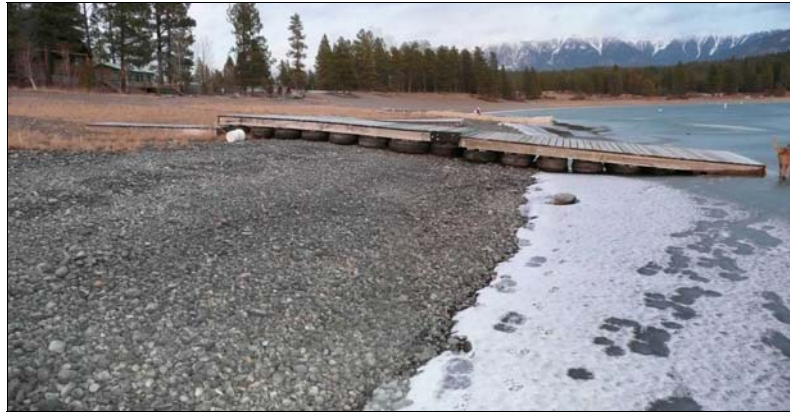
**Figure 15. Example of dock attached to the shore at the low water mark where beach grooming was not evident in Segment 7.**

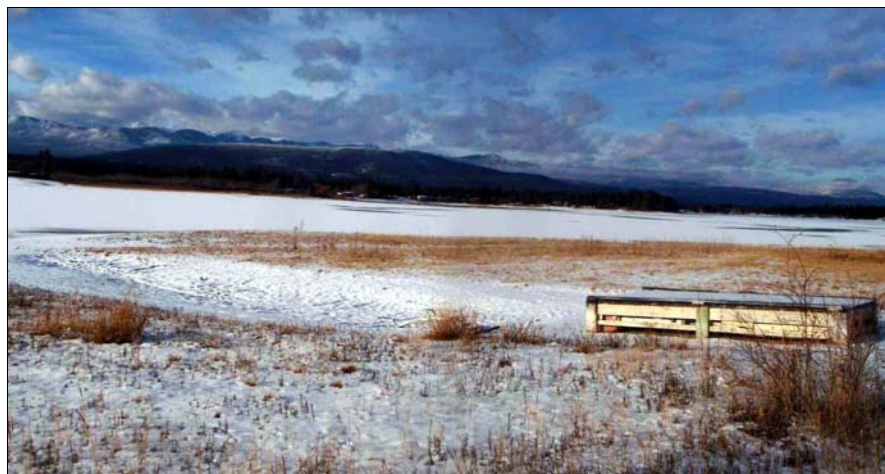
Although, not part of the database, dredging was another modification observed at a few locations around the lake (Segments 1 and 3). Figure 17 depicts a location on Segment 1, which has been dredged in order to allow access up from the shoreline to a dock. This dredging, consequently, appears to have occurred on Crown Land zoned as P-2 Parks and Open Space (RDEK 2002).

Figure 17. Example of area that was dredged in order to allow access to a dock in Segment 1.

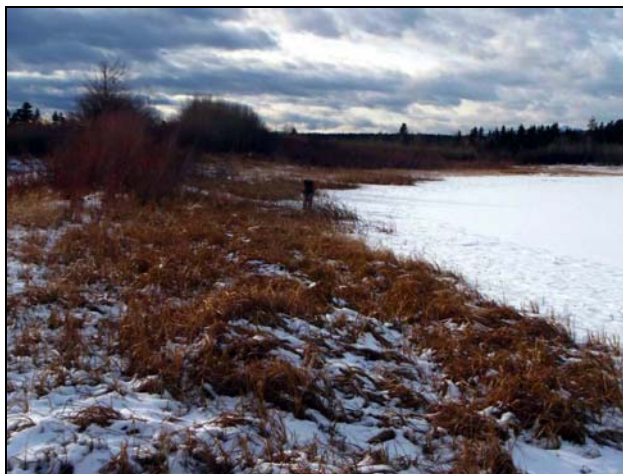
The orthophoto delineation data set created by Terrasaurus was updated in ArcGIS to identify aquatic vegetation evident at low water levels (Appendix C). Species identification was not completed, but this aquatic vegetation appeared to mainly be grasses and herbs, as shown above in Figure 17. A small area of emergent bulrush and cattail vegetation was also identified on the northern shore of the provincial park in Segment 4 (Figure 18). The majority of the aquatic vegetation was likely submerged during higher water levels and they would have become emergent with lowering water levels. This vegetation is anticipated to be beneficial in many ways by providing: bank stability, a filtering agent for nutrients and potential toxins, habitat for fish and wildlife, and foraging opportunities (either directly or through related invertebrate production).

Figure 18. Isolated location of bulrush and cattail evident along Segment 4

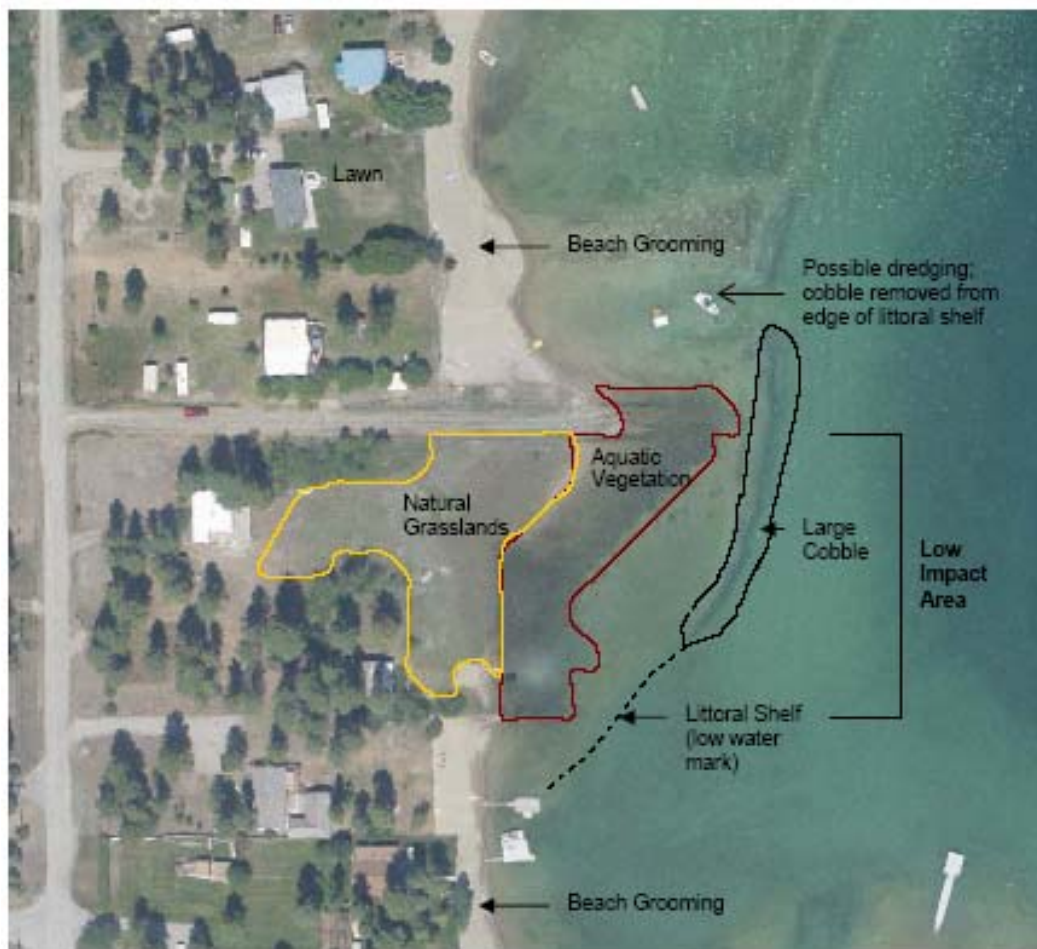
Modifications appear to be converting the physical nature of the lake to sand beach from more diverse shore types such as vegetated and sand/cobble. Figure 20 provides an overview of properties along a part of Segment 3, which exemplify how modifications such as landscaping and beach grooming appear to have impacted the natural shoreline. In this photo, the properties on the north and south ends are evidenced to have been landscaped, beach groomed and have had other modifications (i.e., docks and possible dredging). On these properties, many of the natural features are no longer visible. The central property, however, showed minimal impacts on the shoreline, since it was setback and had limited modifications. As a result, the central property showed extensive area with riparian vegetation (grassland) and aquatic vegetation and cobble substrate in the littoral area. The sand placement on the beach (beach grooming) of the outlying properties appeared to result in loss of natural vegetative and structural features, which are important for biodiversity, aesthetics and water quality. It is important to note that in some locations, (e.g., Segment 6 which is unmodified) some features such as aquatic vegetation, do not exist naturally, as a result of shoreline morphology. An orthophoto review of features for neighbouring, unimpacted properties tends to identify what the natural conditions of a segment once were. This assessment was qualitative, and a thorough quantitative analysis of these relationships was not completed under this project.

**Figure 20. Overview of properties along Segment 3, showing area where the natural shoreline features were kept intact (low impact area) against adjacent properties where development has substantially altered the shoreline.**

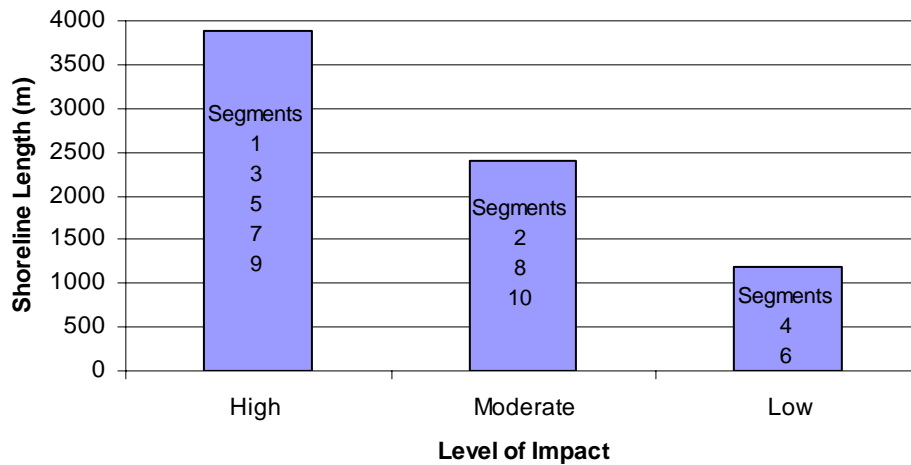
Lol provides a qualitative indication of the overall health of the foreshore and considers the land use, level of disturbance, and modification information presented above. Generally a High Lol refers to a segment with >40% alteration along its shoreline, a Moderate Lol is between 10 and 40% alteration, and a Low Lol segment is mainly natural with <10% alteration. Figure 14 provides a summary of the Lol ratings for Wasa Lake, and reveals that 52% (3,876 m) of the foreshore was determined to have a High Lol, 32% (2,392 m) a Medium Lol, and 16% (1,187 m) a Low Lol. The Segments 1, 3, 5, 7, and 9 were rated as High Lol and as indicated in earlier results included all the residential segments other than Segment 2, which has not been fully developed. The Moderate Lol includes Segment 2, and the Provincial Park Segments 8 and 10 that are highly used for recreational activities and have subsequently had some degree of beach grooming and vegetation alteration. The Low Lol Segments were only those Provincial Park Segments 4 and 6, which appear to have been set aside for biodiversity and protection of habitat. Photos of segments representing each of these Lols at Wasa Lake are provided in Figures 21 - 23.

**Figure 21. Segment level of impact (LoI) rating (High = >40%, Moderate = 10-40% and Low = <10%) and total shoreline length (m) attributed to each of the LoI ratings.**

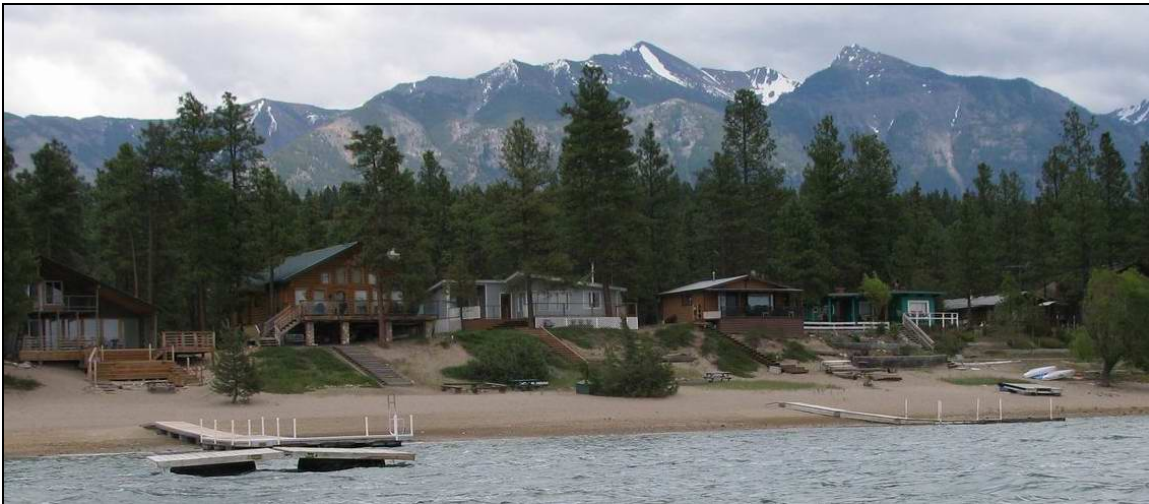
**Figure 22. High Level of Impact example (Segment 1), showing how development has impacted most of the shoreline.**

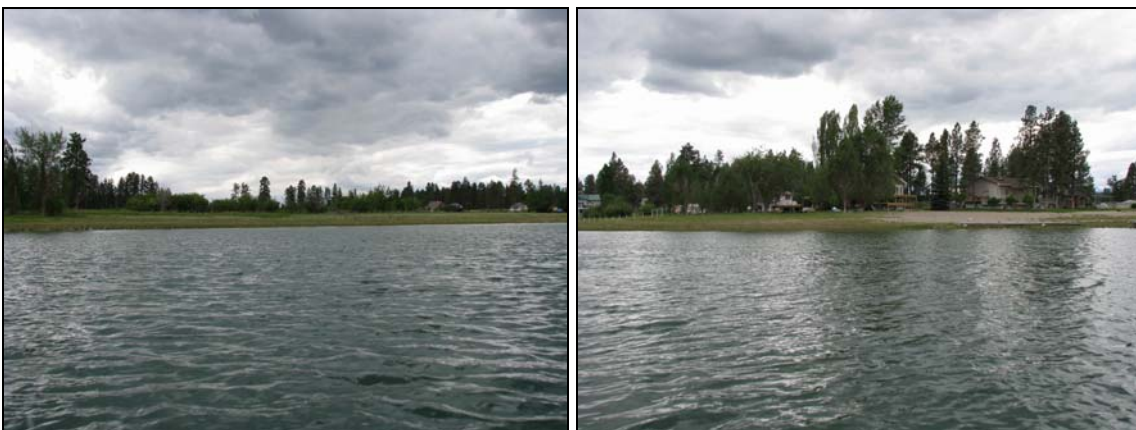
**Figure 23. Moderate Level of Impact example (Segment 2), showing how development has impacted approximately 30% of the shoreline.**

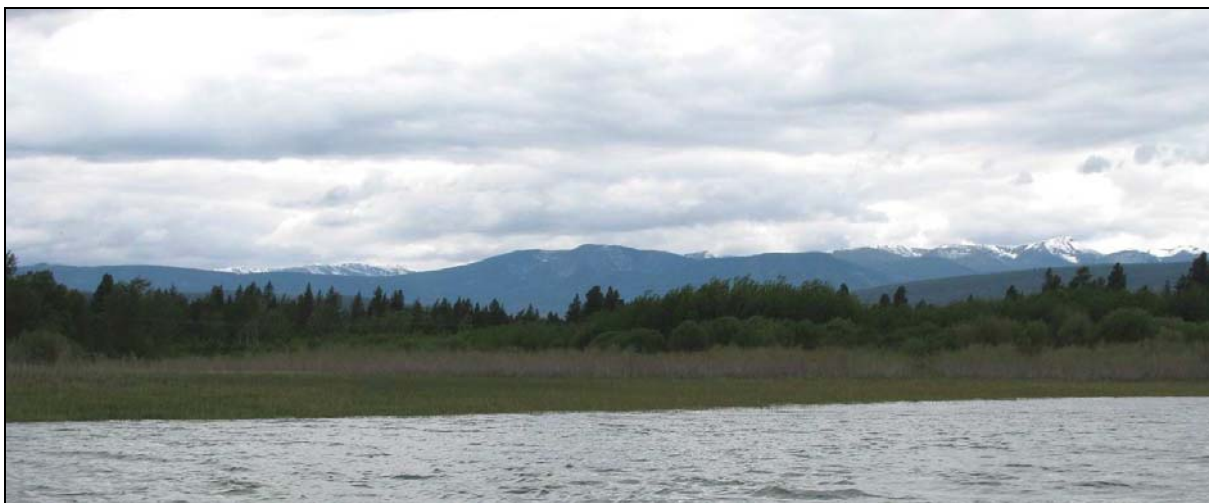
Figure 24. Low Level of Impact example (Segment 4), where the wetland shoreline features are undisturbed and protected as a Provincial Park.

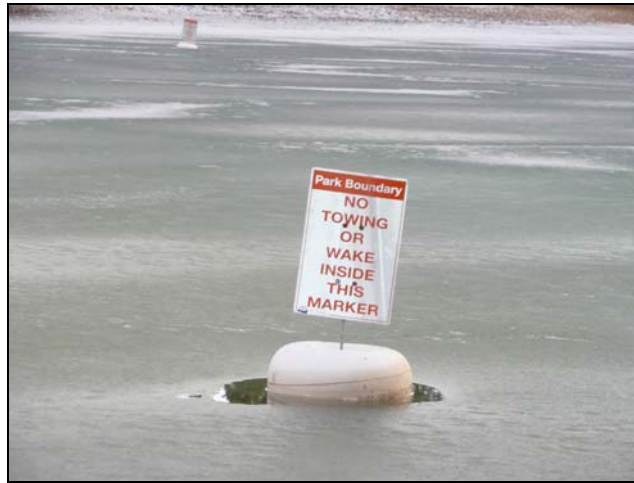
**Figure 25. Signage minimizing recreation impacts inside the bay of Segment 6.**

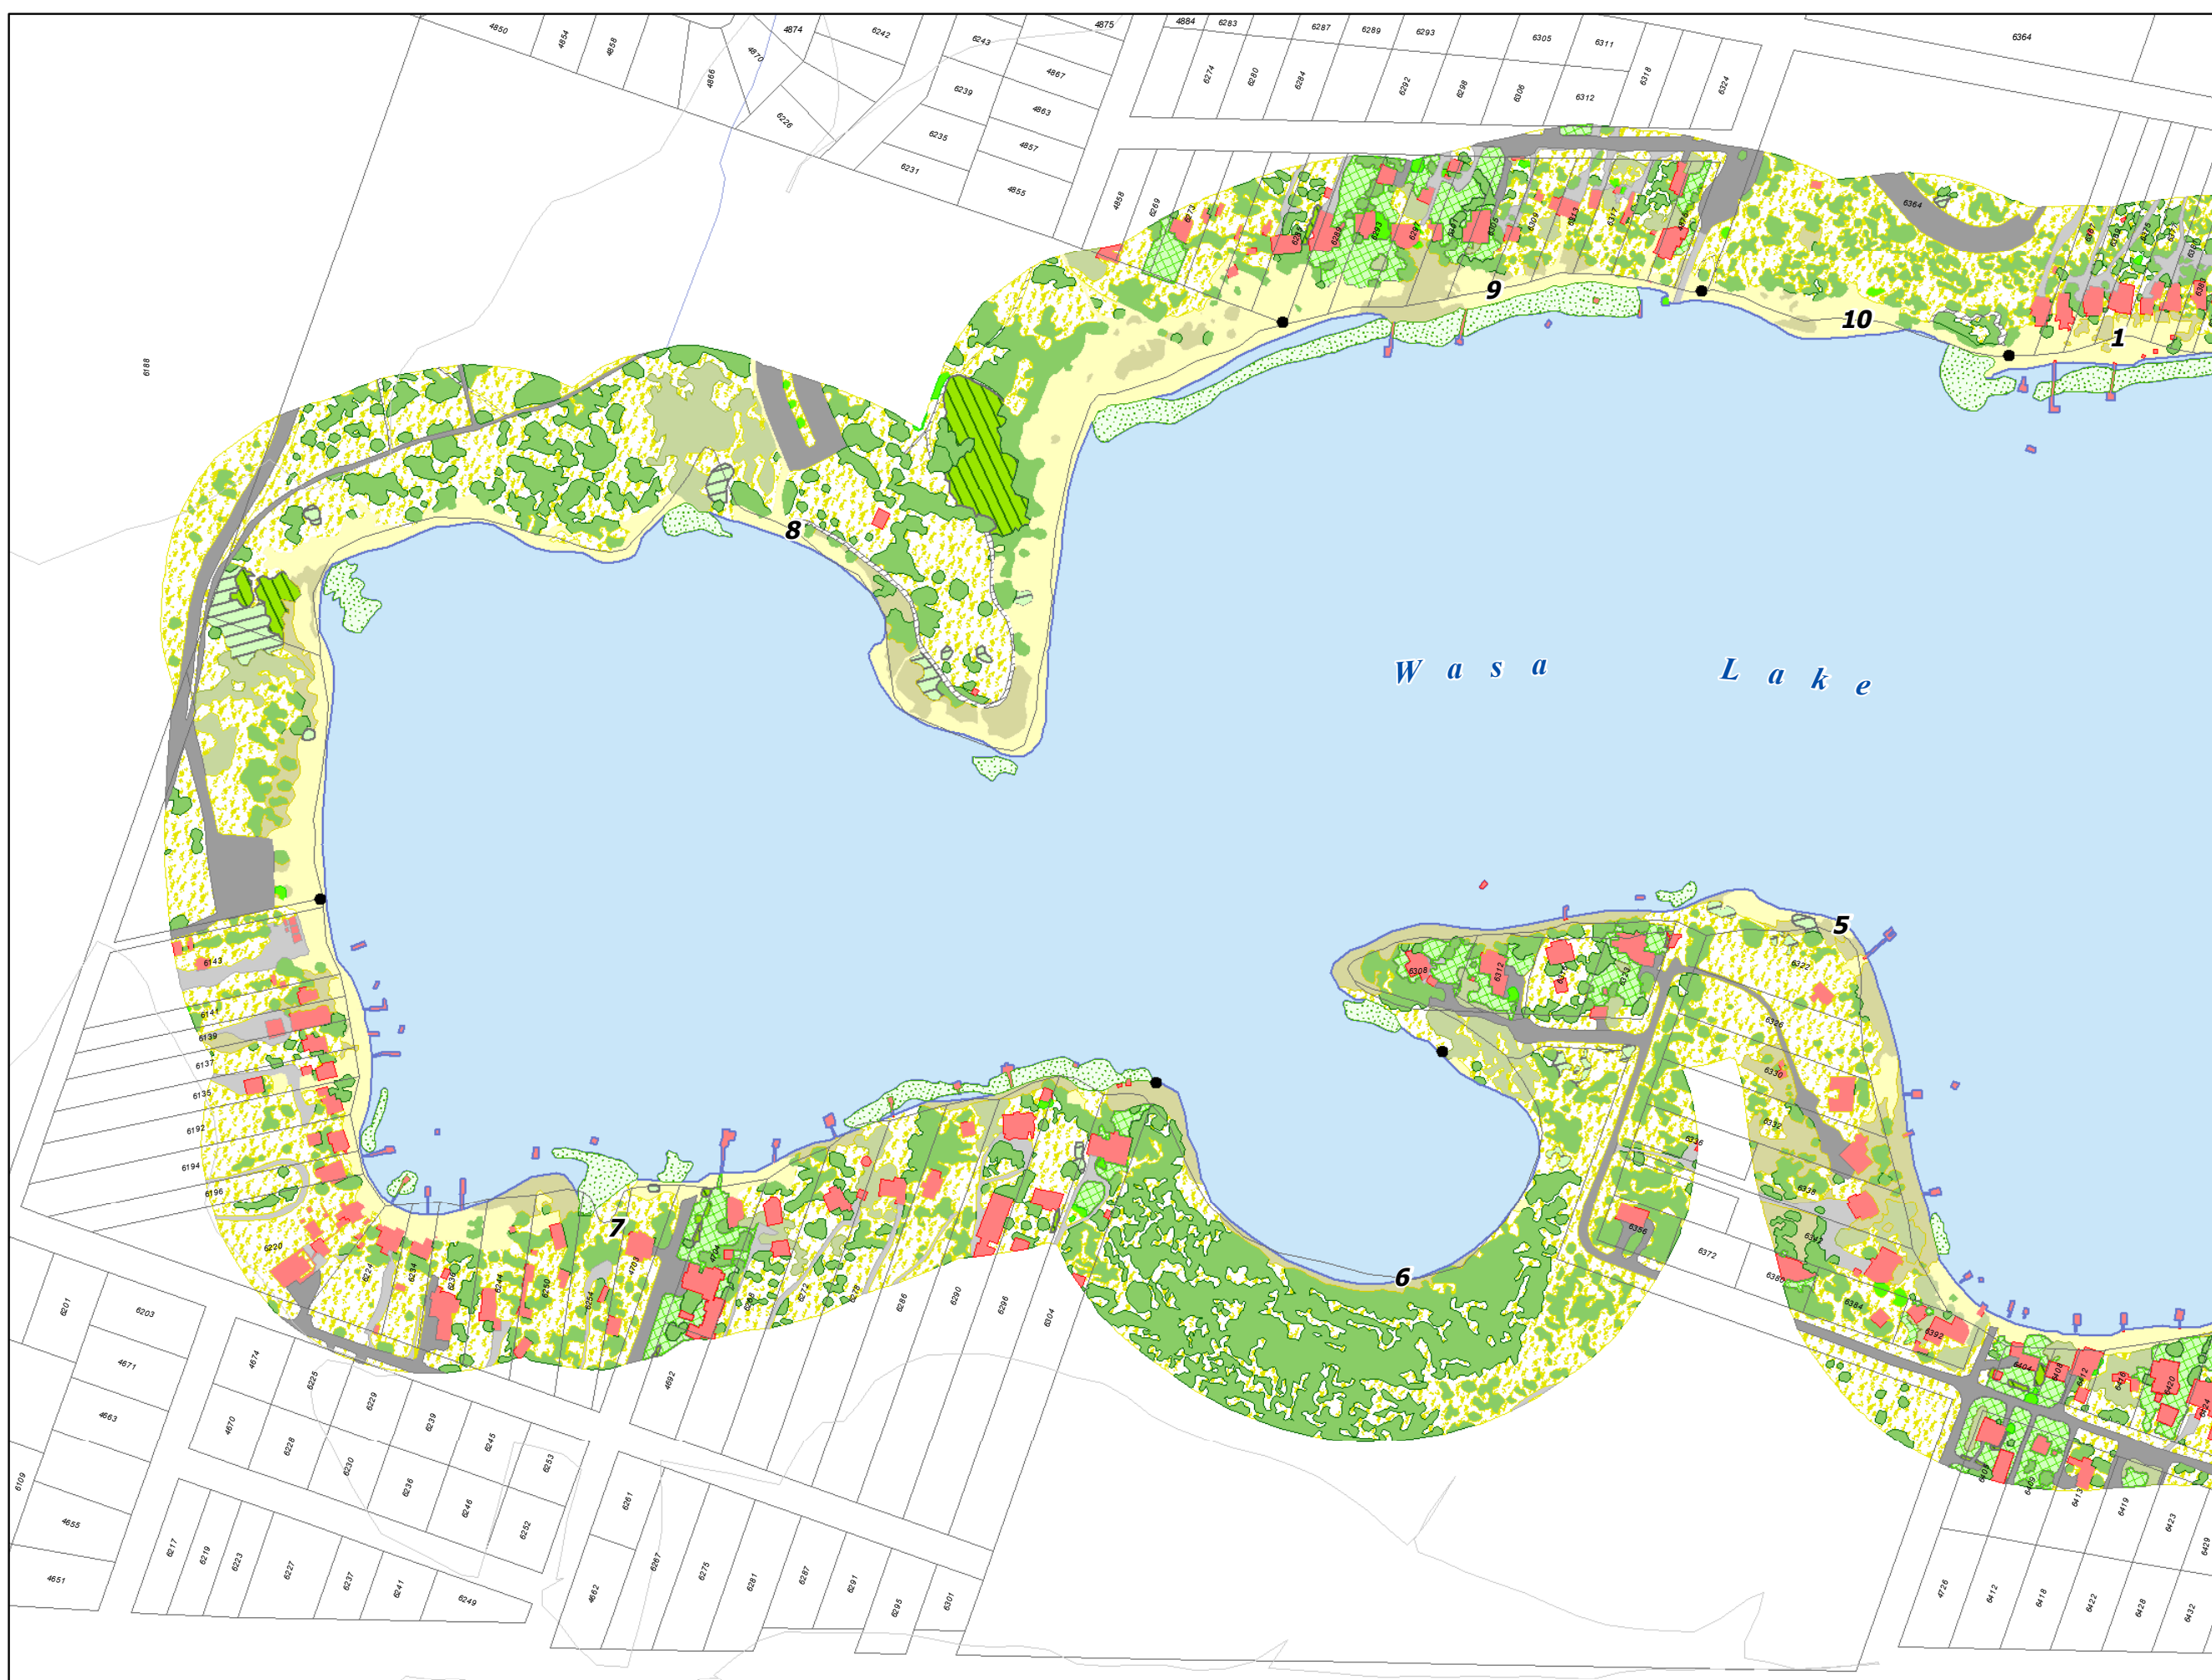
Appendix C: Orthophoto Delineation Map  
Wasa Lake - North

The orthophoto delineation of Wasa Lake's foreshore identified six natural, coarse-level plant communities around Wasa Lake: coniferous forest, deciduous forest, high shrub, low shrub, grasslands, lawn and wetlands (Appendix C). In-growth and grassland degradation are identified as known management issues for Wasa Lake Provincial Park and a restoration plan has been drafted (MoE 2003).

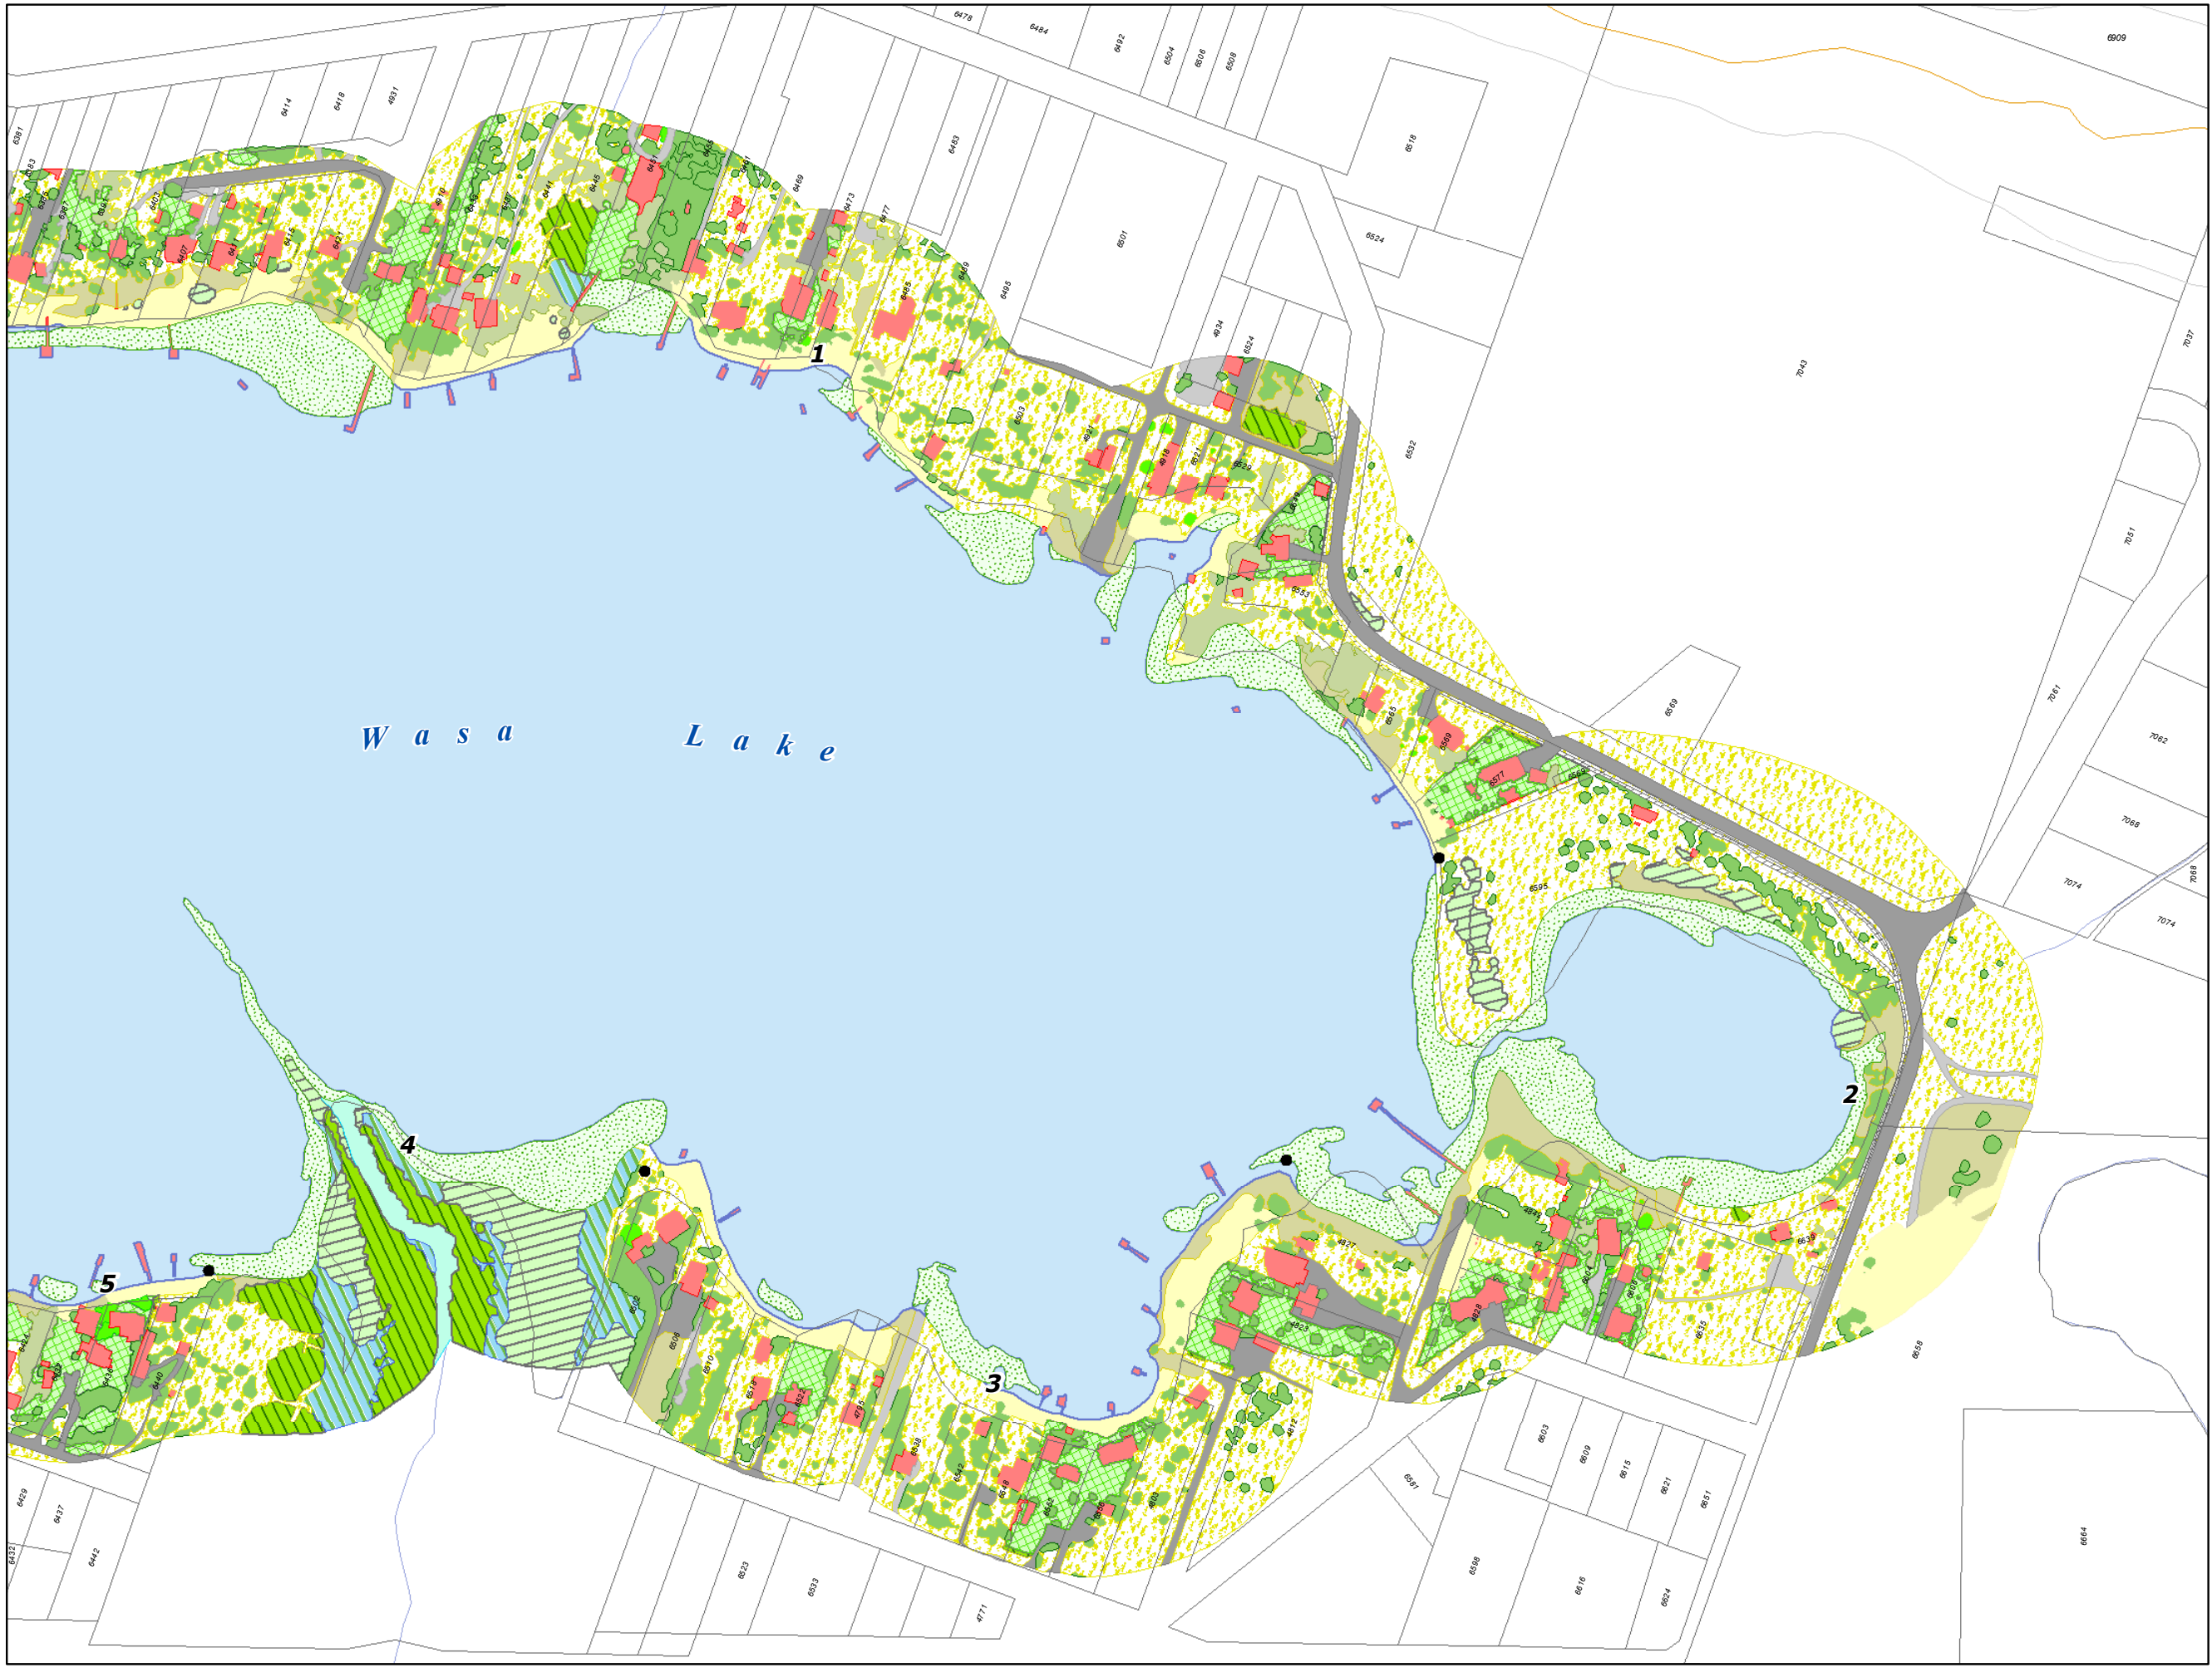
Appendix C: Orthophoto Delineation Map

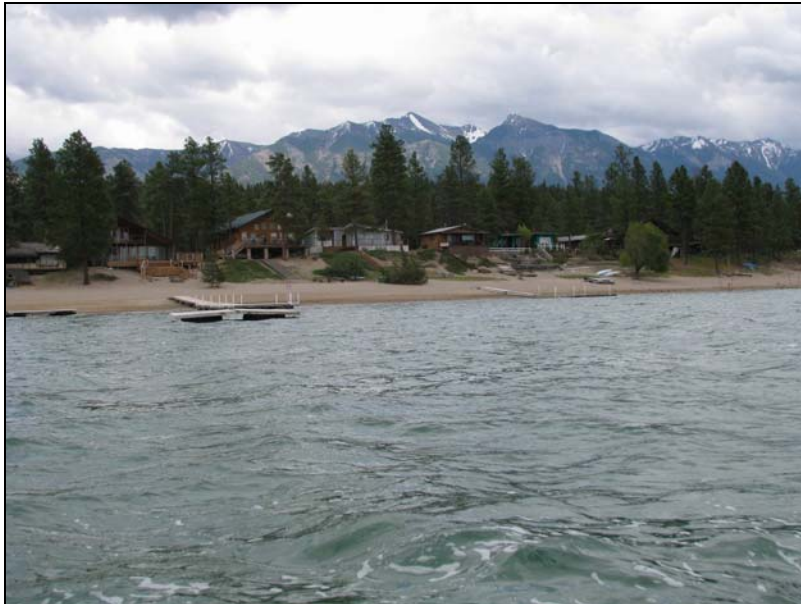
Segment 1 showing sand beach evident at high water levels and residential development.  
Photo: Holmes, June 2008.

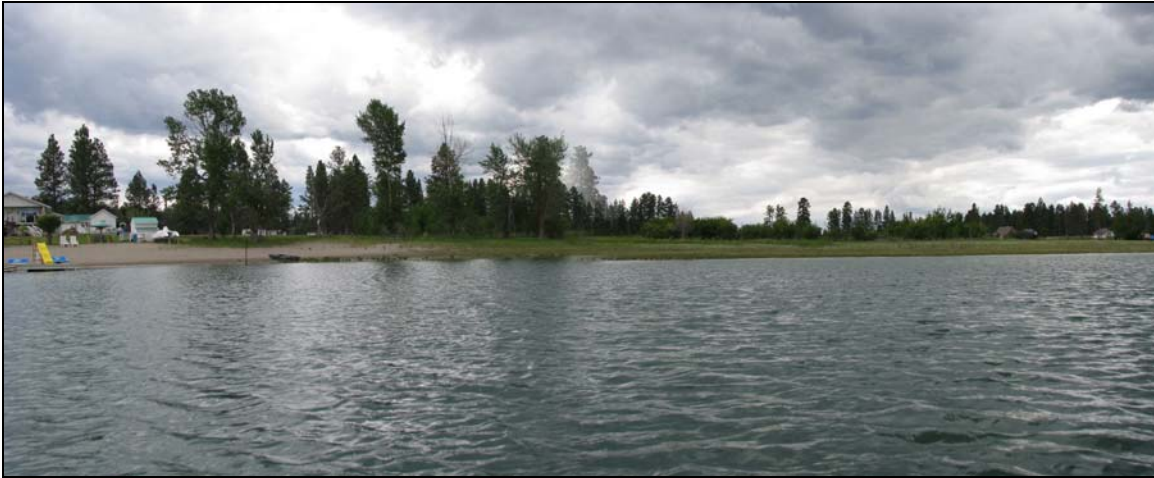
The edge of the sandy beach marks the end of Segment 1 (disturbed area) and beginning of Segment 2 (vegetated area). Photo: Holmes, June 2008.

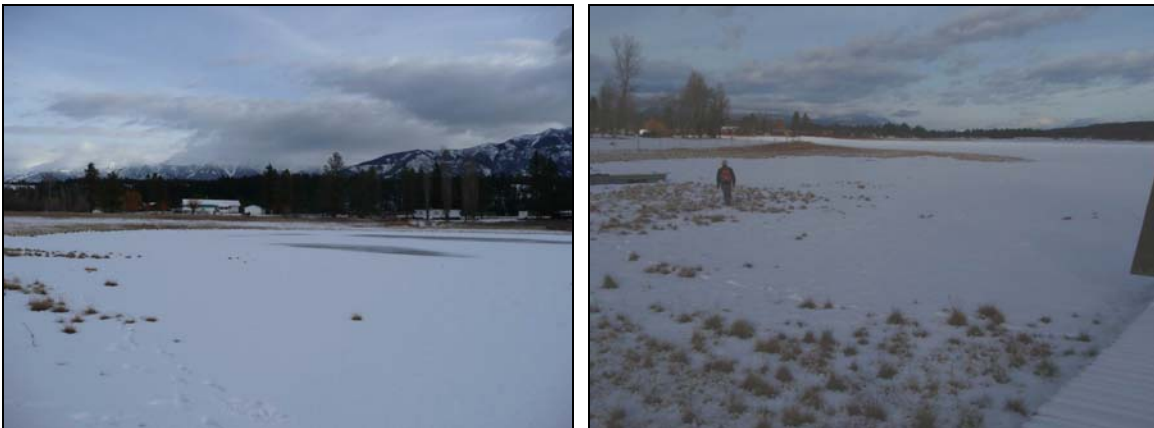
Segment 2: Looking across the bay toward area of emergent vegetation (left) and view toward the west end of the segment (right). Photo: McPherson, Dec 2008.

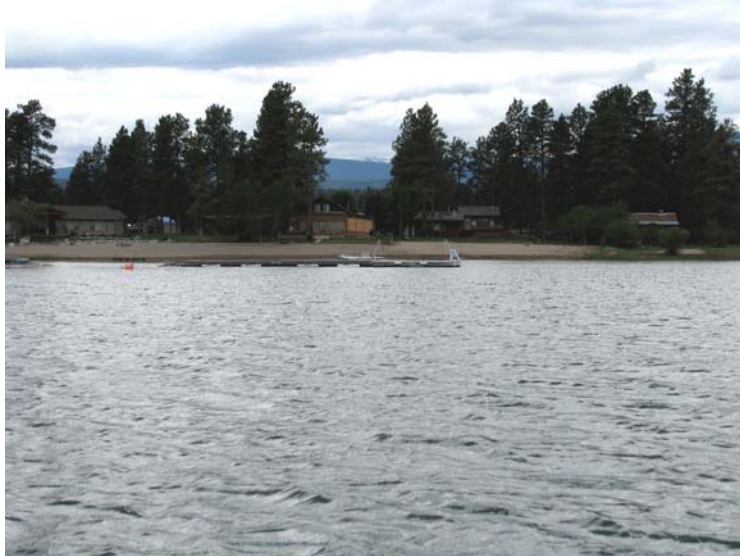
**Segment 3 showing extensive sand placement along the shoreline and coniferous trees in the upland area.**

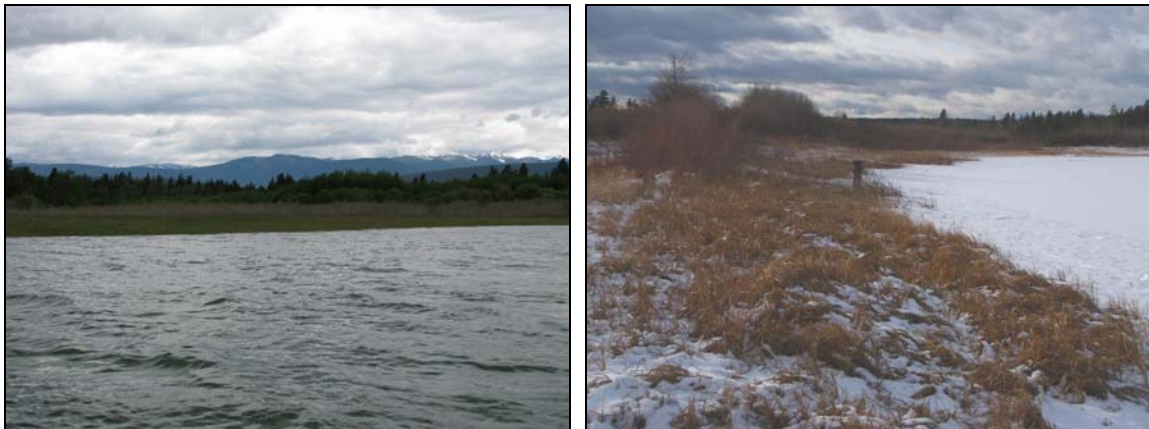
**Segment 4 showing wetland in June (left) and bulrush/emergent vegetation wetland plants near northern end in Dec. (right). Photos: Holmes, June 2008 and McPherson, Dec 2008.**

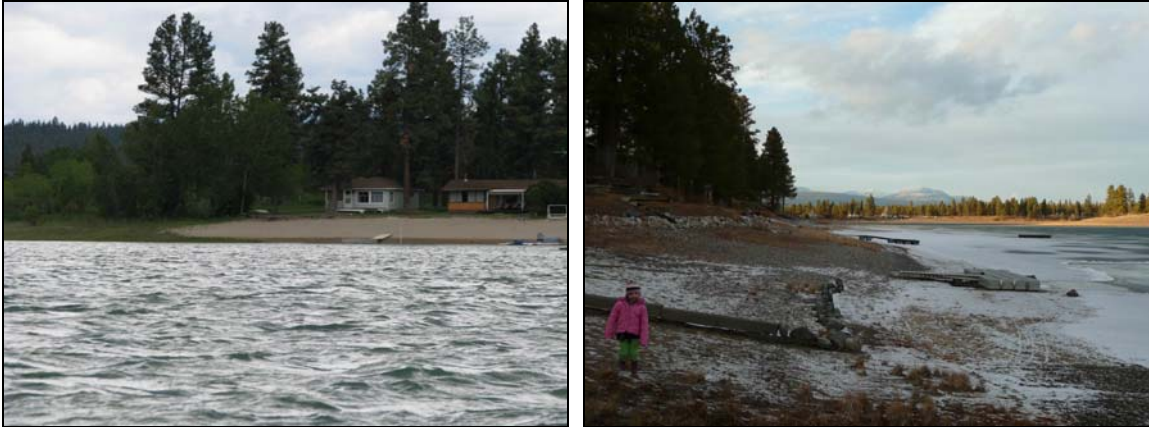
Segment 5 at the south end boundary with the park (left) and towards its northern end (right).  
Photos: Holmes, June 2008 and McPherson, Dec 2008.

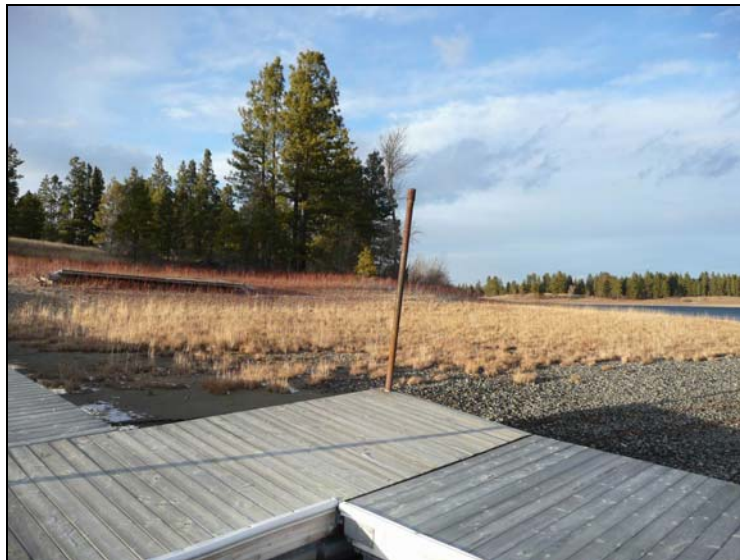
Segment 5 shoreline area that has been left relatively intact, exhibited by emergent vegetation and cobble substrates below high water mark, along with grassland/coniferous mix of vegetation in riparian area. Photo: McPherson, Dec 2008.

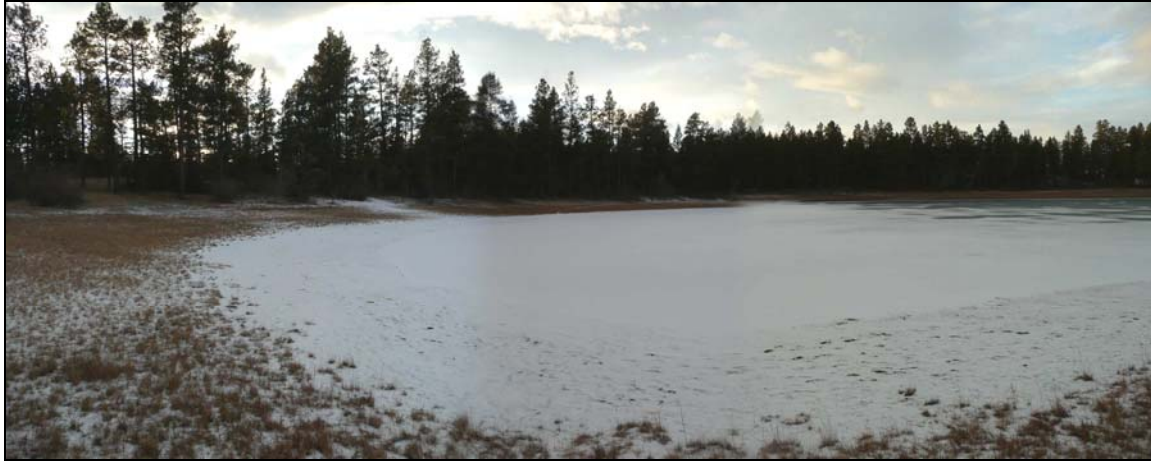
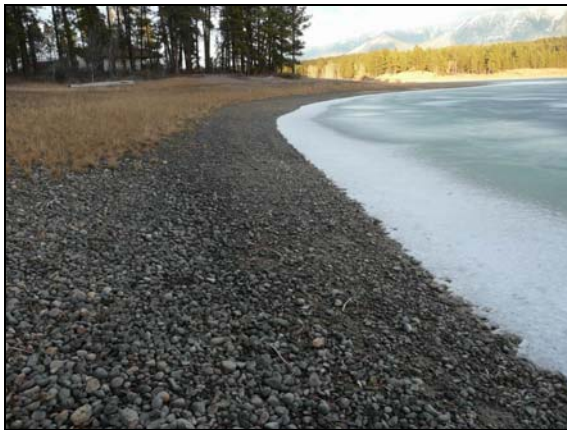
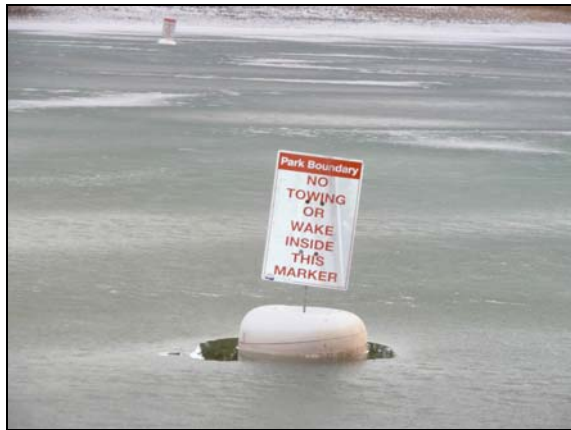
**Segment 6 foreshore area showing grasses along the riparian area followed by conifers in the upland (top), cobble substrates along southern stretch (bottom left) and park signage protecting habitat (bottom right). Photo: McPherson, Dec. 2008.**

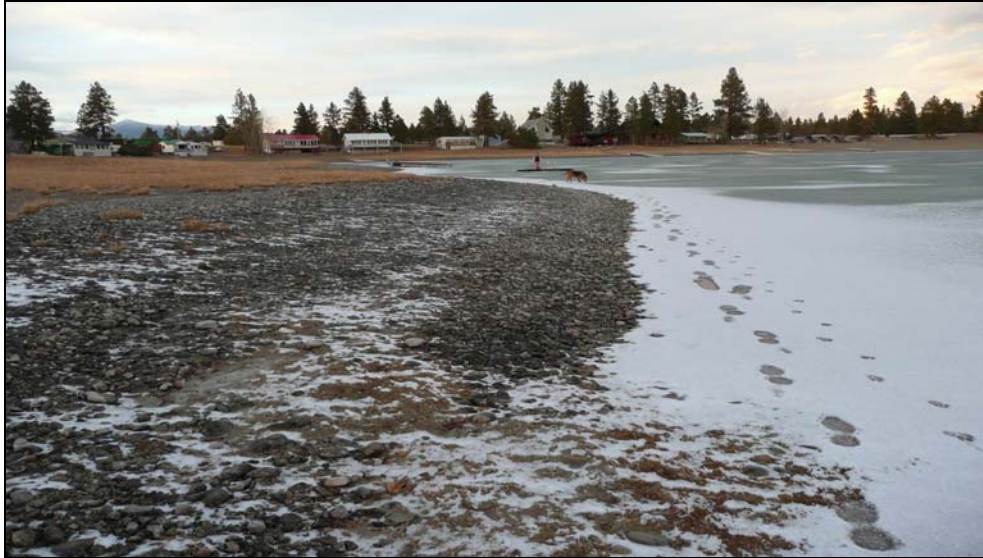
**Segment 7, showing cobble substrates evident at low water levels and area where grasses have been maintained to the high water level. Photo: McPherson Dec. 2008.**

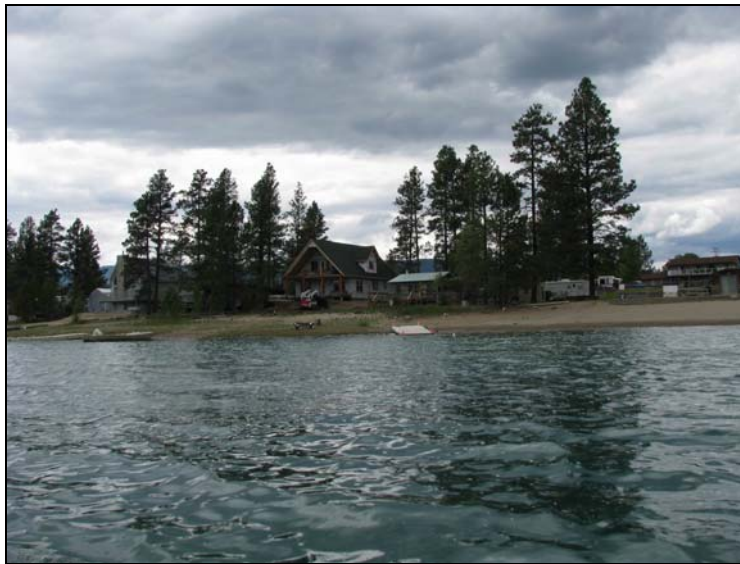
**Segment 7, showing property on left where some vegetation along the shore has been left intact and property on the right where beach grooming and retaining wall modifications have greatly altered the natural shoreline. Photo: Holmes, June 2008.**

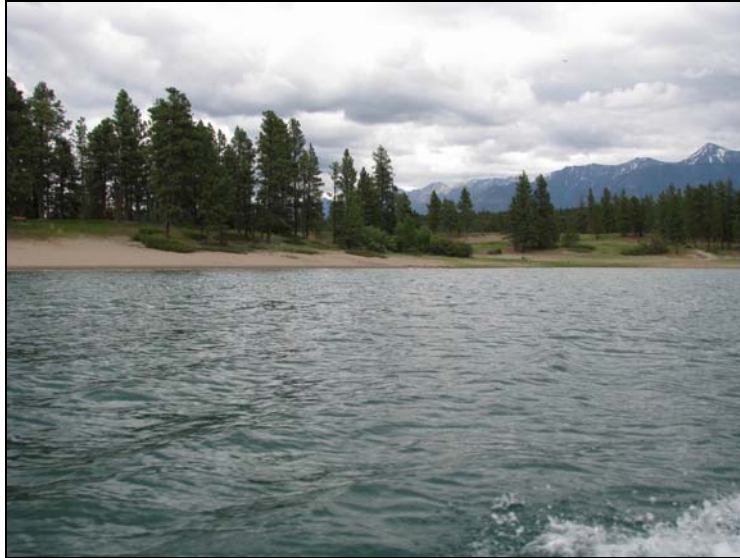
**Segment 8 showing the Sand Beach Shore Type and upland area composed of open ponderosa pine grassland.**
