## **Wasa Lake Foreshore Inventory and Mapping**

**Prepared for:  
Wasa Lake Land Improvement District**

**Final Report  
February 2009**

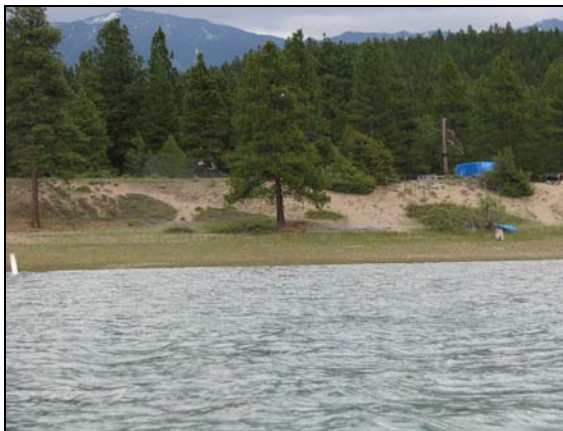
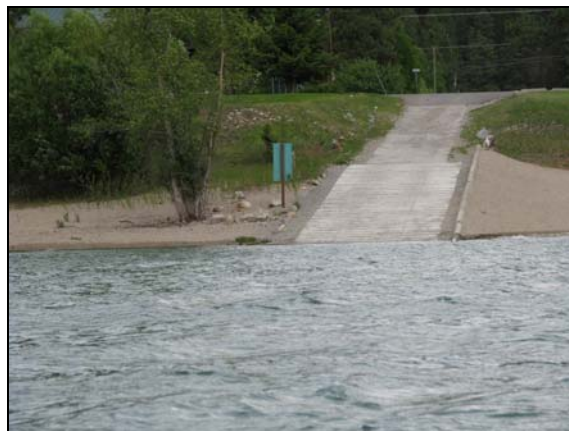
**Segment 9: An example location where grass/herb vegetation has been maintained along the shoreline and of houses situated up on a bench (left) and boat launch/groyne structure at end of the segment (right). Photo: Holmes, June 2008.**

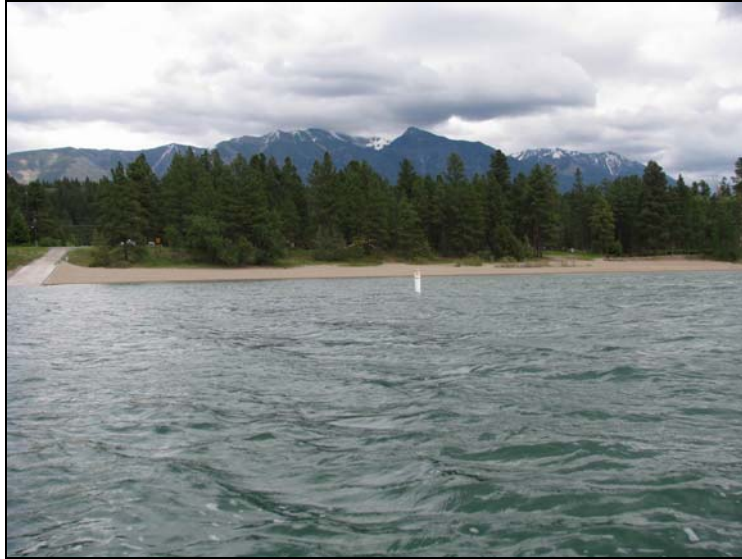
**Segment 10 is a park developed for recreational purposes. The segment starts just to the south of the boat launch and includes the extensive beach area. Photo: Holmes, June 2008.**
